USARTL-TR-78-22

CH-47 CRASH TEST (T-40) STRUCTURAL, CARGO RESTRAINT,
AND AIRCREW INFLATABLE RESTRAINT EXPERIMENTS

April 1978

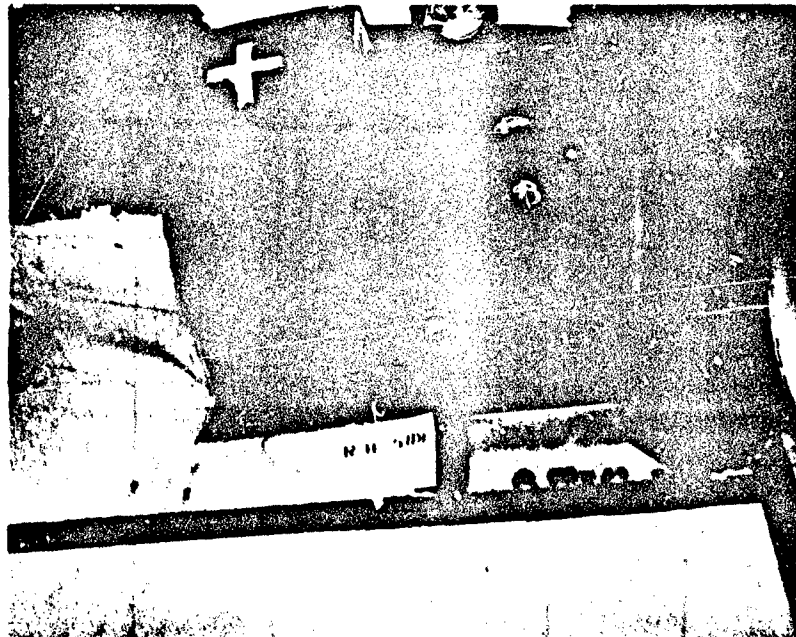
Figure 16. Rear engine mount failure.

The transmission and engine mounts adequately retained these components, preventing their penetration into the helicopter's occupiable interior. As an example, a failed rear engine mount is shown in Figure 16.

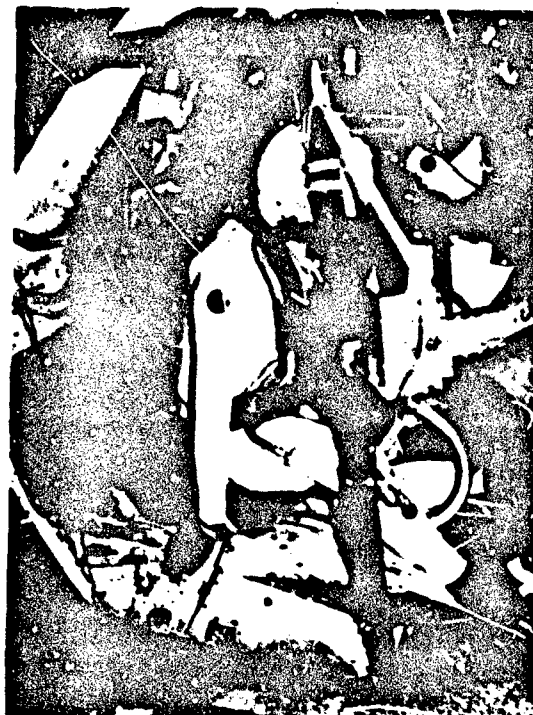
Figure 43. Post-test cockpit showing crash damage and dummy position.

A review of the motion pictures revealed that the inflatable restraint system functioned properly during the crash. Although the seats were considerably deformed by the crash forces, the inflatable restraint was able to constrain the dummy in the pilot seat (Figures 42 and 43). Unfortunately, the inertia reel on the copilot's seat failed, releasing the shoulder straps and allowing the dummy to pitch forward in the seat. This unforeseen failure eliminated all chance for a meaningful comparison of the data collected from transducers on both dummies.
